January 12, 2022

Re: **Damage Evaluation – Report of Findings**
Project Name: Cole and Christina Francis
Project Address: Lace Ave. Fairfax, MO 64446
Zurich File #: 5630071912
J.S. Held File #: 21101796

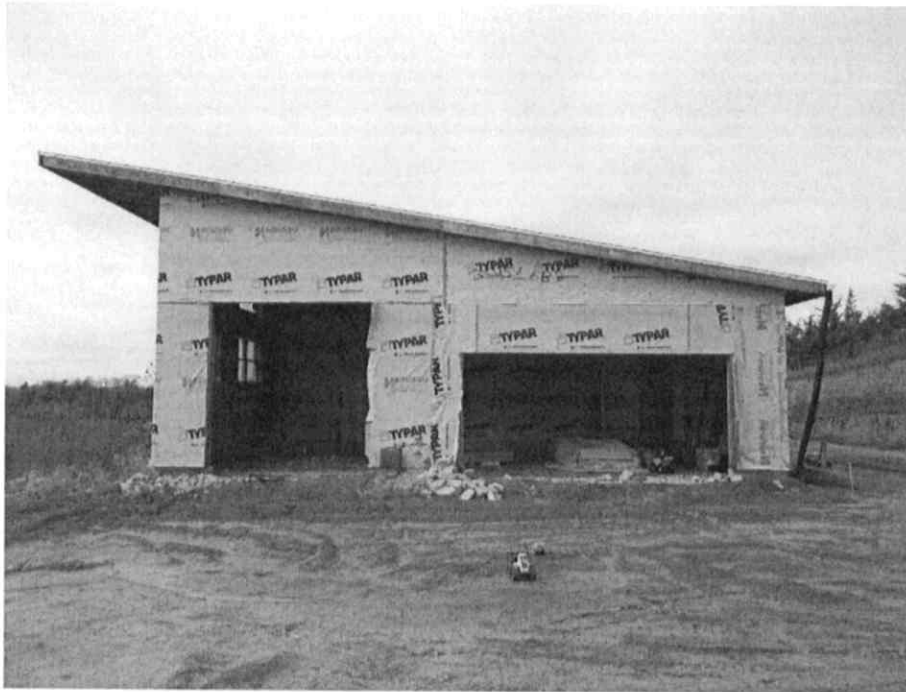
The top surfaces of the foundation stem walls at the garage door openings were observed to have rough surfaces characterized by jagged and loose chunks of concrete. Additionally, pieces of broken concrete were strewn along the ground adjacent to the stem walls. (Appendix A, Photos 1-3)

Photo 1: View of the east elevation showing the overhead garage door openings.

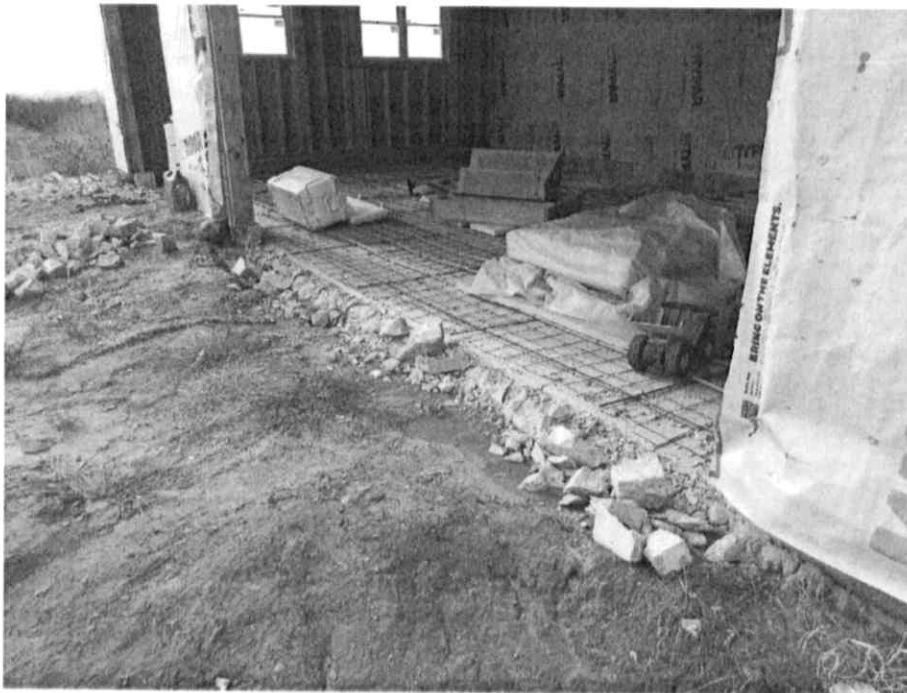
The strewn concrete remnants and rough surfaces to the top of walls within the overhead door openings were consistent with the wall having been constructed too high, and subsequently having been lowered via jackhammering as reported by the owner. This scenario was an as-constructed issue, and therefore J.S. Held concluded that:

Photo 2: View of remnant concrete chunks along the foundation stem walls at garage openings.

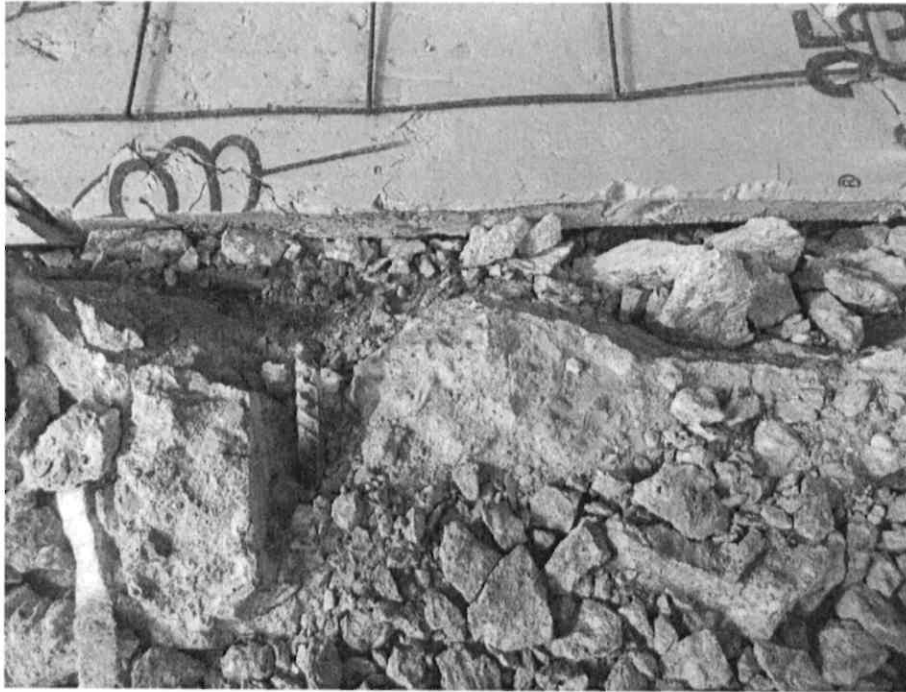
The improper foundation stem wall heights at the overhead garage door openings were the result of deficient construction of the foundation.

Photo 3: View looking downward at the top surface of the foundation stem wall at overhead garage door openings, showing jagged and loose concrete.

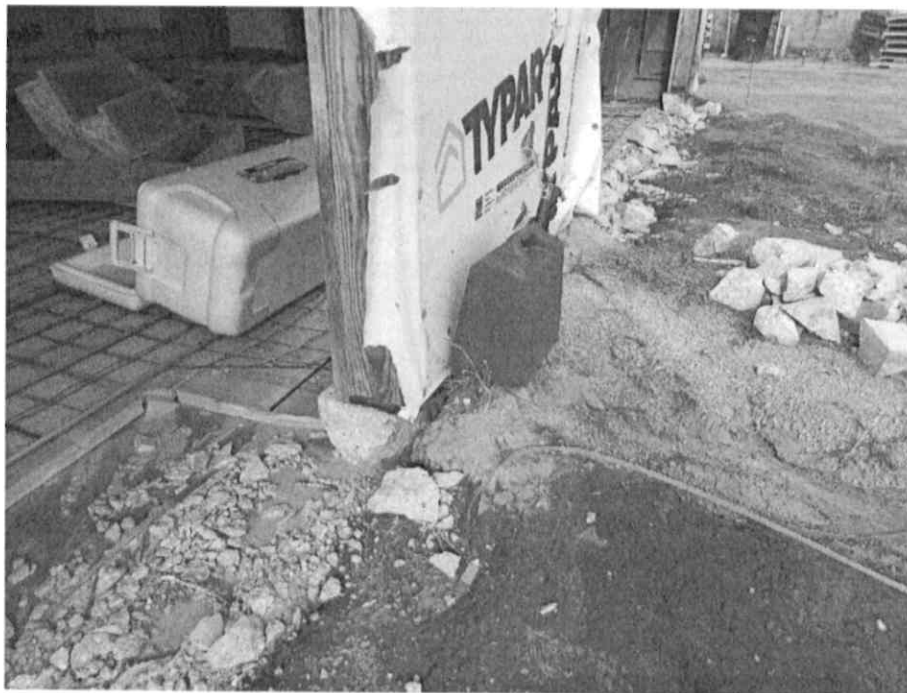
At the east elevation of the garage, the outside faces of the wood framed exterior wall, 2x6 sill plates overhung past the outside faces of the concrete stem walls. The amount of overhang increased from the northeast corner to the southeast corner of the garage, with the maximum amount at the southeast corner being approximately a 2.25-inch overhang. (Appendix A, Photos 4-7)

Photo 4: View of the exterior wall at east elevation of garage between the overhead doors. See also next photo.

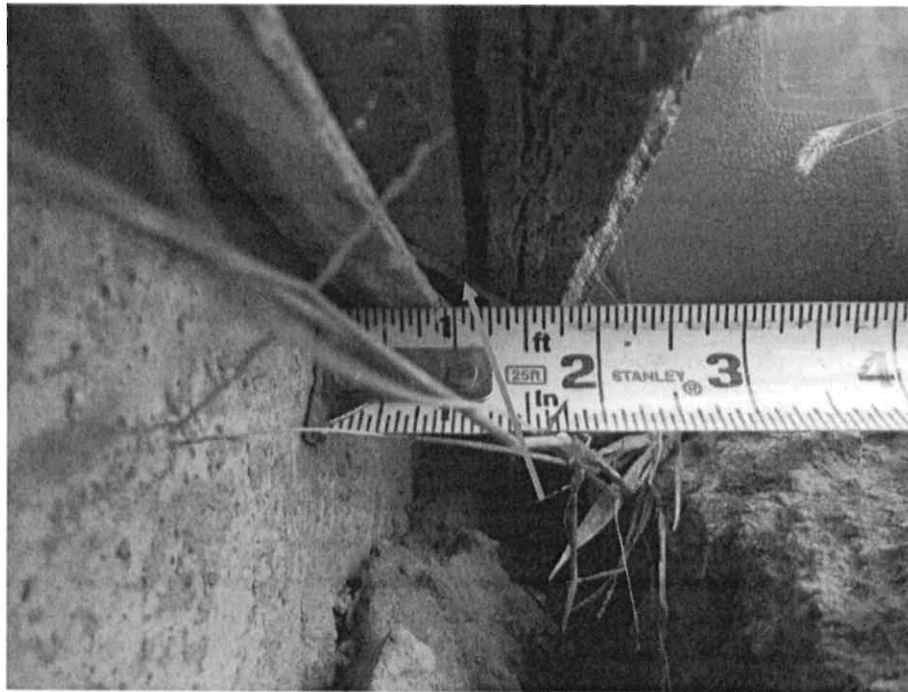
The misalignments and excessive overhang of wood-framed garage walls off the foundation was the result of deficient construction of the foundation and/or the prefabricated exterior stud walls.

Photo 5: View of approximate 1 inch overhang of east exterior wall sill plate (red arrow) off the outside face of concrete foundation wall.

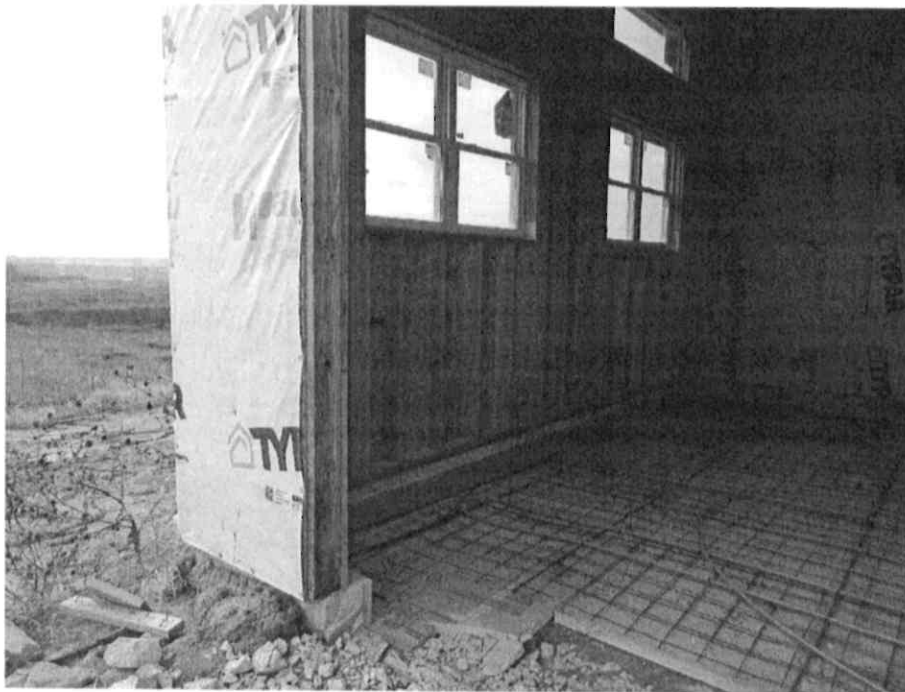
Photo 6: View of the exterior wall at east elevation of garage at the southeast corner of the garage. See also next photo.

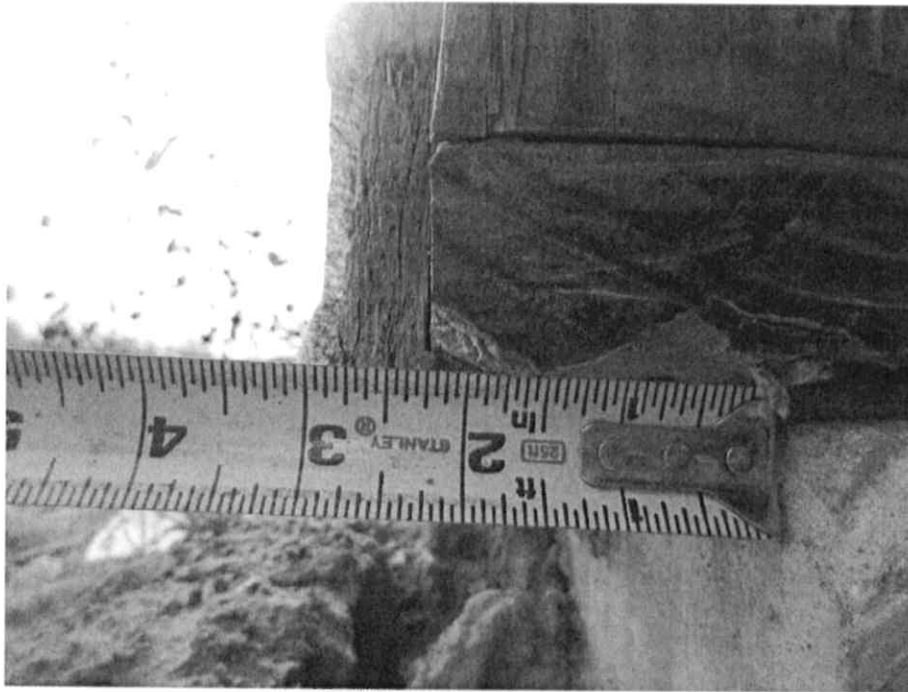
Photo 7: View of approximate 2.25 inch overhang of east exterior wall sill plate off the outside face of concrete foundation wall.

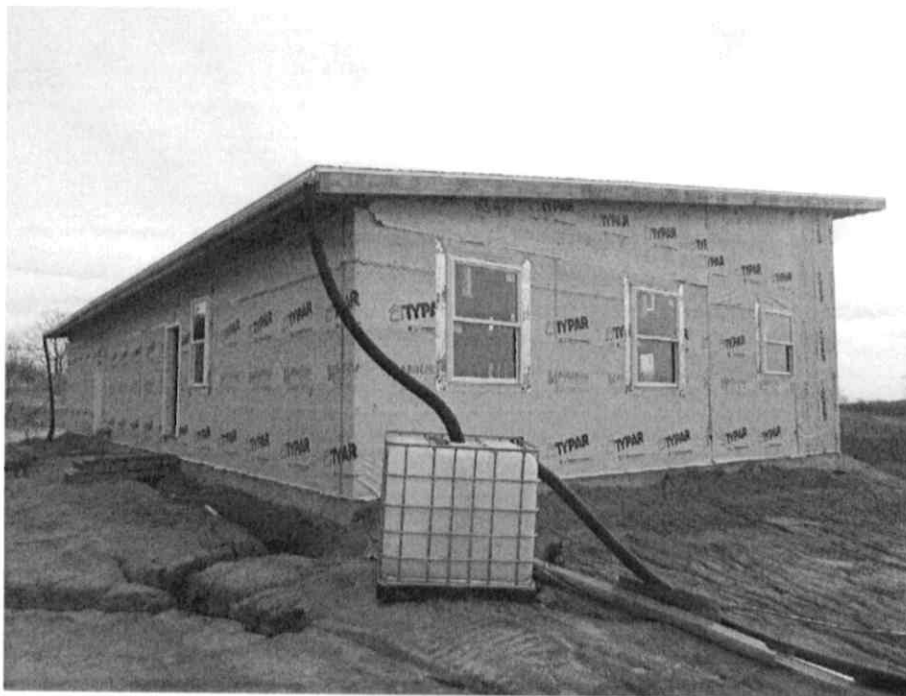
At the northwest corner of the foundation, a concrete crack wrapped around the corner, located approximately 4 inches below the top of the wall. The crack extended diagonally upward along each of the north and west foundation walls, approximately 8 to 10 inches in each direction before terminating at the top of walls. A relatively small piece of concrete (approximately 1/2 inch in depth) had spalled off the north wall along the crack location. Additionally, another concrete spall was located approximately 6 to 8 inches below the corner crack; The spall was about 4 inches tall by 2 inches deep and had spalled off the exterior corner of the wall. No cracks were visible to the inside face of concrete at this area. (Appendix A, Photos 8-13)

Photo 8: View of the west and north elevations of the residence showing the northwest corner of the residence in the foreground.

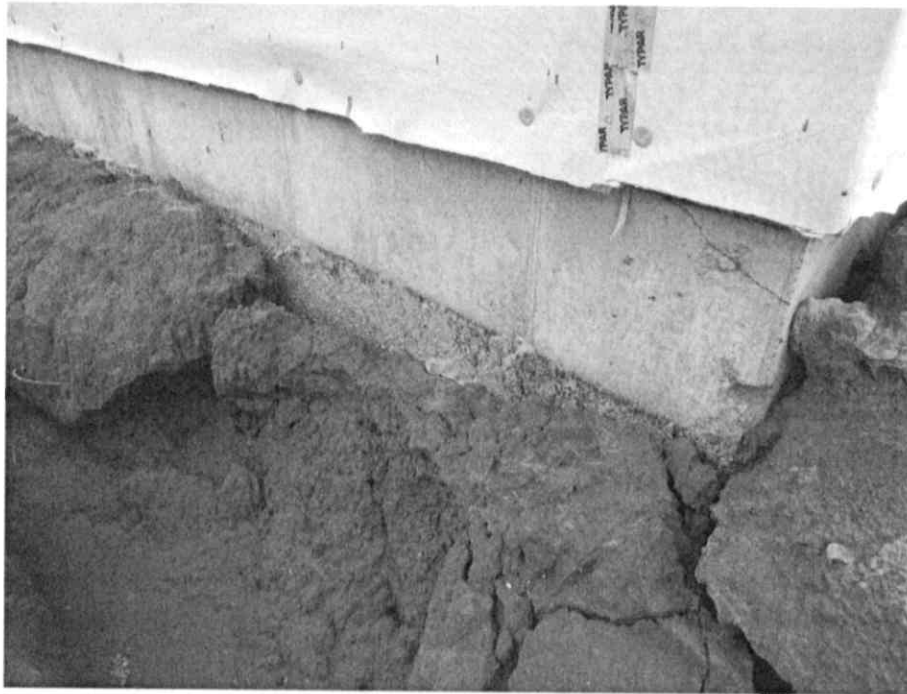
The owner reported that a skid steer had impacted the foundation wall, causing the crack and spall damage, during foundation backfilling or other movements nearby the northwest corner of the residence. Although this exact reported event could not be confirmed, the observed crack and spall damage, and the localized nature thereof, was consistent with the type of concrete damage that would result from such as impact by a sufficiently hardened and heavy object. Therefore J.S. Held concluded that:

Photo 9: View of the northwest corner of the foundation showing a concrete crack and the top of corner and spalled concrete below the crack. See also next photos.

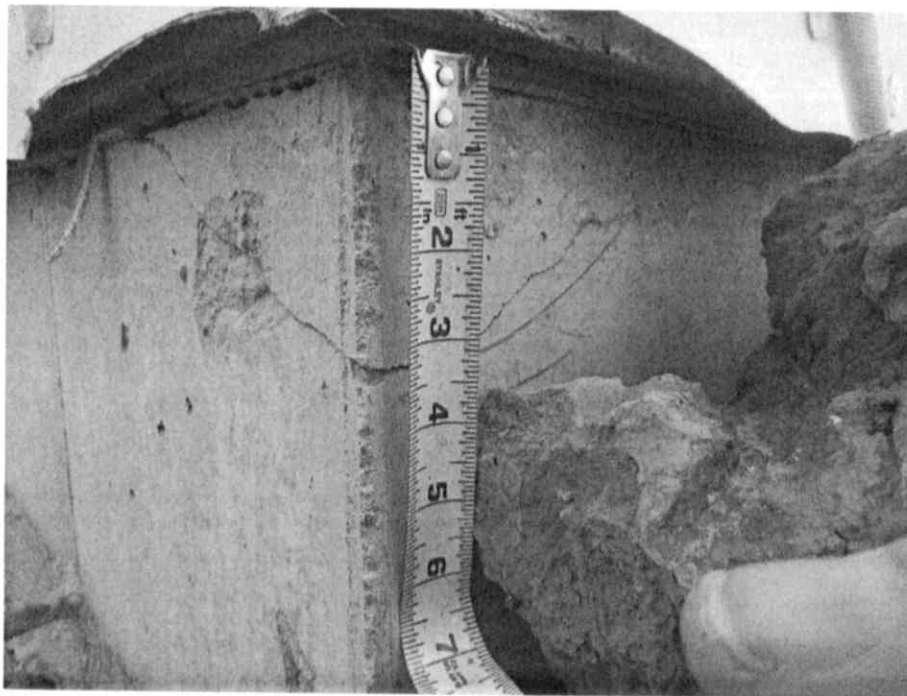
The cracked concrete at the top of foundation wall at the northwest corner of the foundation was reported to have occurred due to impact by construction machinery such as a skid loader during backfilling. J.S. Held could not confirm this as the specific cause of the crack, however the crack damage was consistent with an impact from heavy machinery as described.

Photo 10: View of the northwest corner concrete crack at the top 4 inches of foundation wall height, extended upward along the north and west foundation walls approximately 8 to 10 inches in each direction before reaching the top of walls.

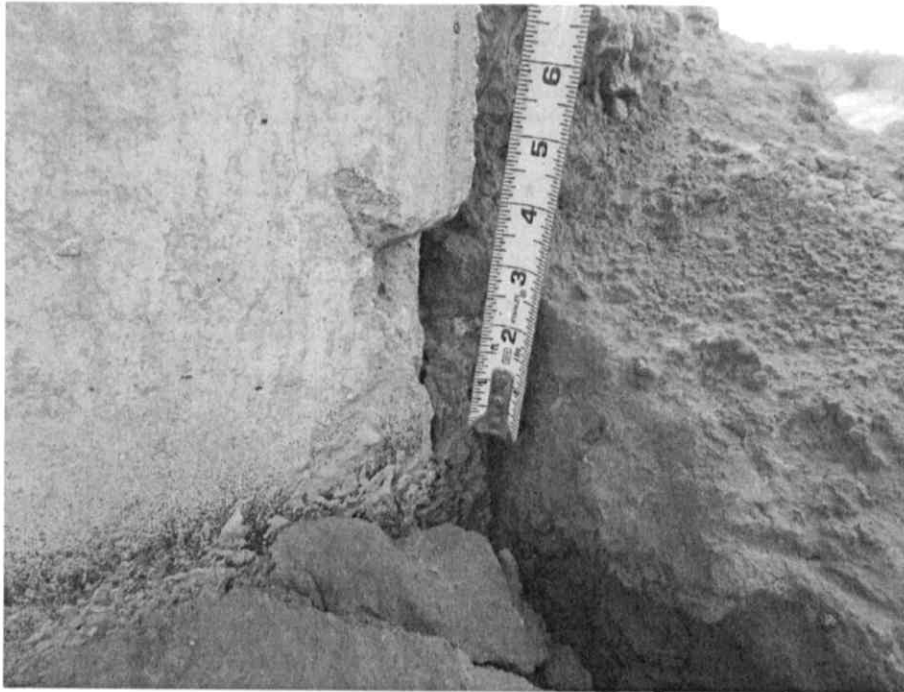
Photo 11: View of spalled concrete off corner of foundation below the concrete crack area.

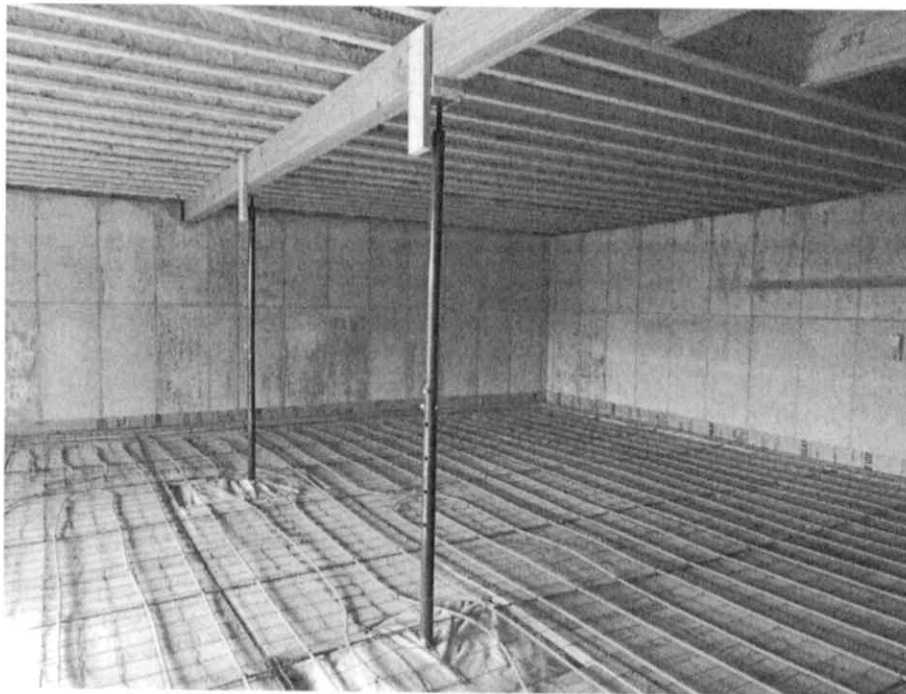
Photo 12: View within the basement looking northwest toward the northwest foundation wall corner.

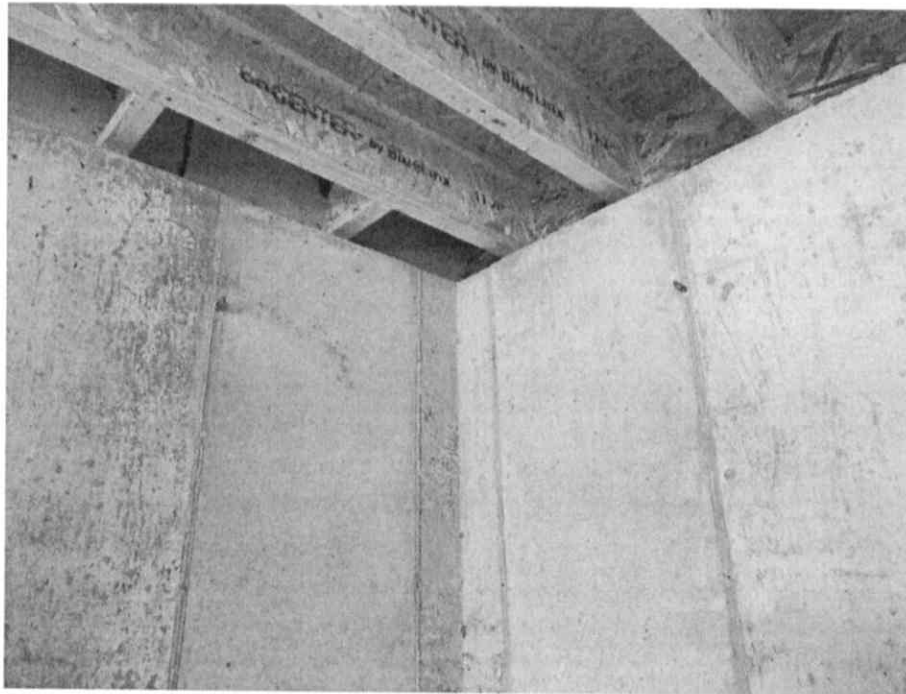
Photo 13: View of the top portion of the foundation wall at the northwest corner showing an absence of visible cracks.

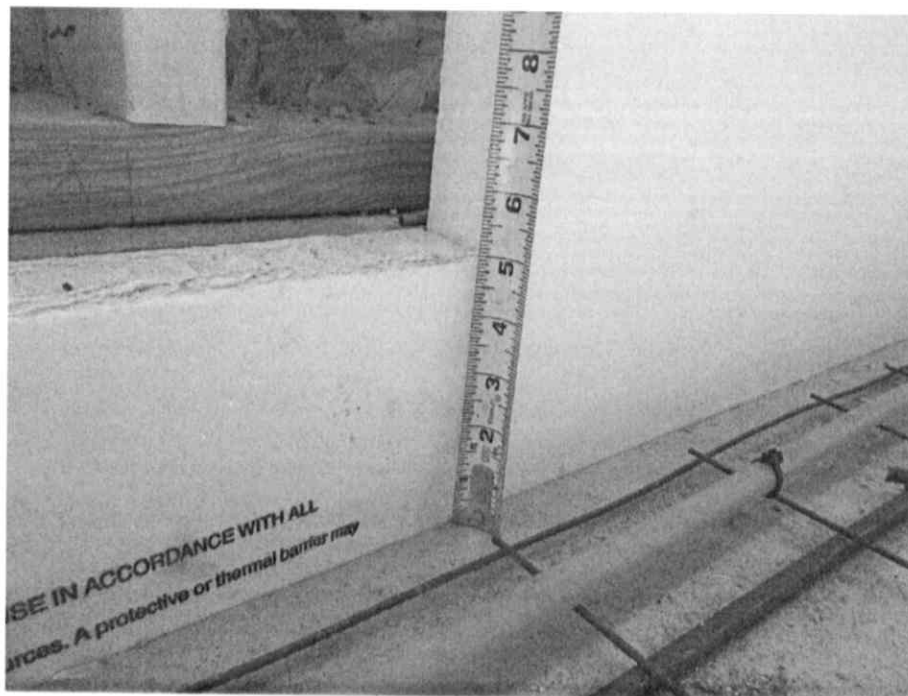
At the interior basement floor area, rigid insulation was in place atop the earthen subgrade, along with welded wire fabric, steel rebar, and radiant heat tubing above the rigid insulation in preparation for placement of the concrete floor slab-on-grade. Along the south elevation of the basement, the top surface of the rigid insulation varied in depth. It was measured to be 5 inches below the top of the foundation wall at the west end of the wall, and 3 inches below the top of foundation wall at the east end of the wall. (Appendix A, Photos 14-15)

Review of the architectural plans, specifically Section D-D of Sheet A4, revealed that the basement floor was to be a concrete slab-on-grade floor constructed over rigid insulation, and with the top of concrete floor slab elevation to be aligned with the top of the south foundation stem wall. Based on the measurements taken along the south wall, the as-prepared rigid insulation surface would lead to a 5-inch slab thickness at the western end of the wall and a 3-inch slab thickness at the eastern end of the wall. Therefore, the rigid insulation had not been accurately set to allow for a 4-inch concrete floor slab thickness. The top elevation of the rigid insulation would have been a function of both the prepared surface elevation of the earthen subgrade below, and the thickness of the insulation. As such, one or both components had necessarily been inaccurately constructed. Therefore, J.S. Held concluded that:

The insufficient subgrade preparation depth for the basement floor, which would prevent adequate concrete floor slab thickness in some areas, was caused by deficient construction of the site grading and/or insulation placement.

Photo 14: View of a basement floor location where the top surface of rigid insulation on the ground was 5 inches below the top of exterior foundation wall.

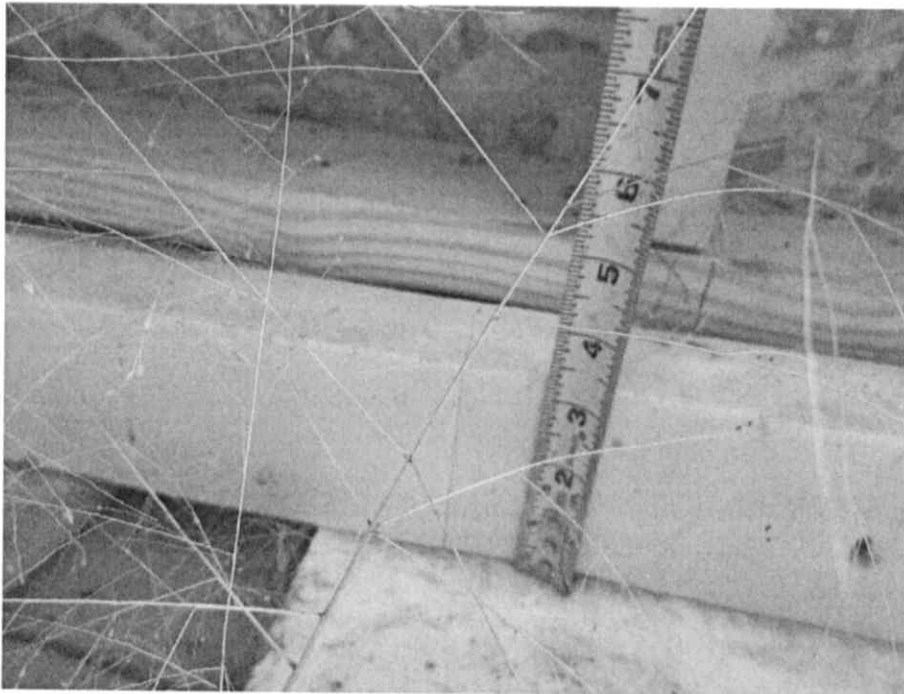
Photo 15: View of a basement floor location where the top surface of rigid insulation on the ground was 3 inches below the top of exterior foundation wall.

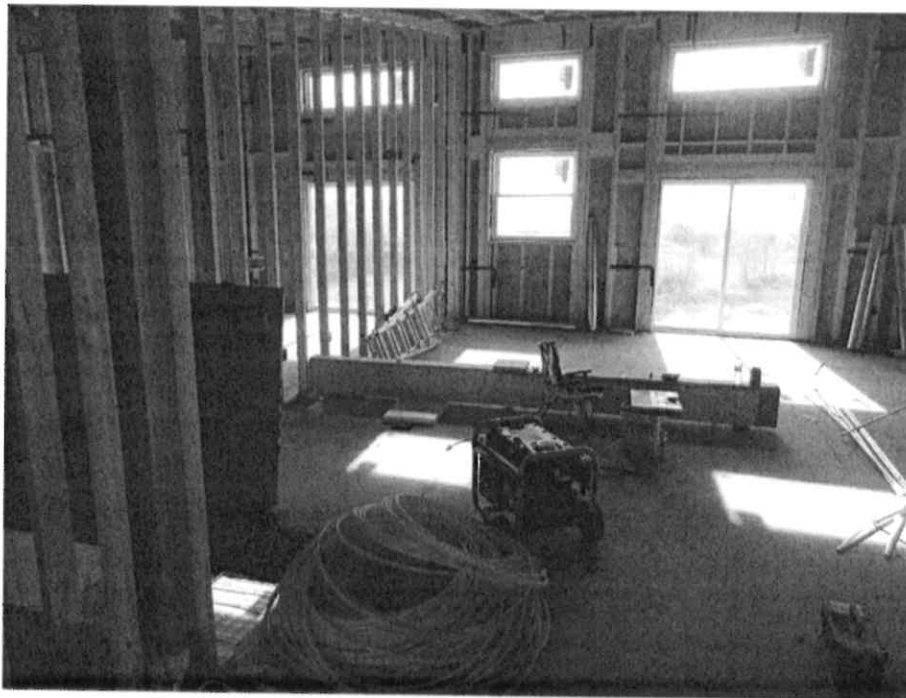
At the main level, interior floor in the Living Room, two adjacent oriented strand board (OSB) subfloor panels exhibited spalled areas of the OSB. The spalls were relatively small in size (approximately 2 inches or less in width or length), and were coincident with nail locations along the ends of the panels. In addition to spalls, there were some instances of upward-delaminated OSB material surrounding nail locations. Several adjacent panels had been installed with alignment of panel ends atop one single floor joist. Several nails fastening the OSB to the floor joist along the end joints had driven through the underside of the floor joist flange, making the nail shanks visible, and two different types of nails were present: rink shank and smooth shank. (Appendix A, Photos 16-24)

Photo 16: View of the main level, interior floor space looking south into the Living Room area.

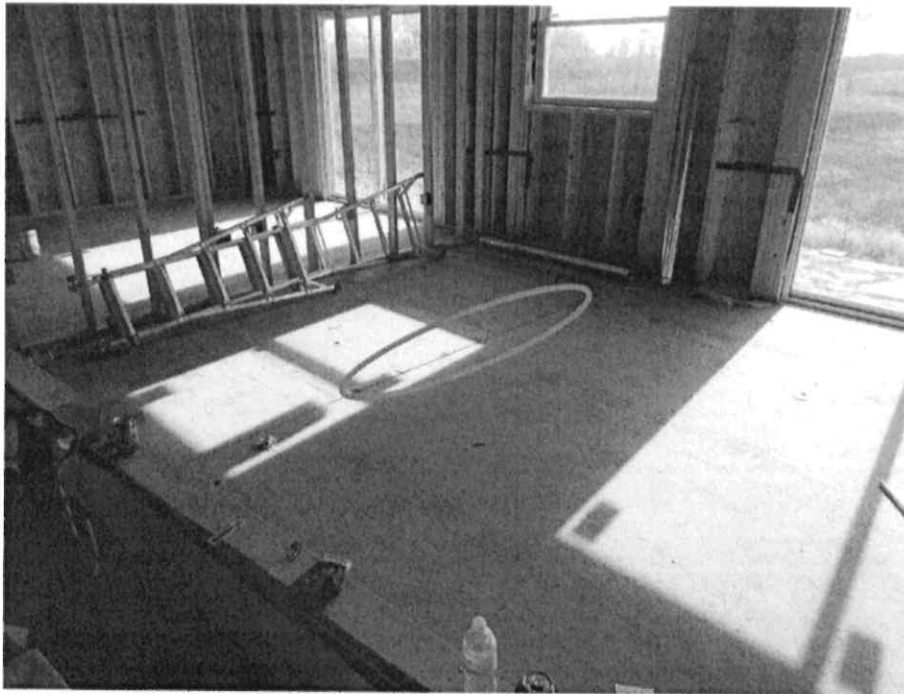
The spall areas at fastener locations along the top surfaces of two main level subfloor sheathing panels were caused by deficient or haphazard construction during the installation of the panels.

Photo 17: View of the Living Room area, with red oval added to identify the locations of spalls within the OSB subfloor.

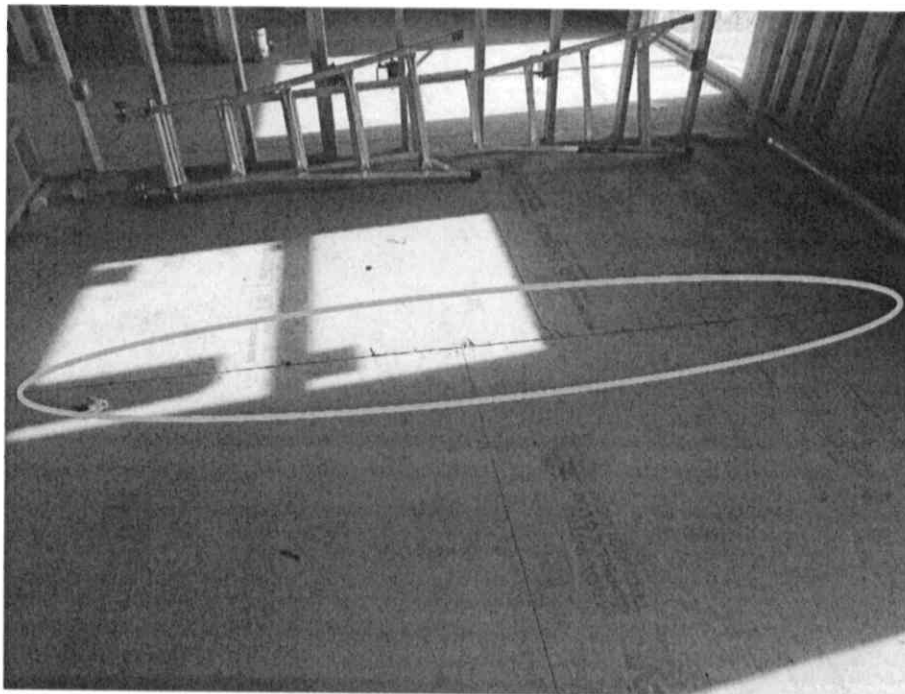
The physical damage to the OSB surrounding the nail fasteners was consistent with either a concentrated downward impact and/or a concentrated internal upward force from embedded nail heads. Concentrated downward impacts could come from a hammer strike when manually hammering nails into the wood, or, from a pneumatic nail gun overdriving a nail into the wood due to over-pressurization. Conversely, an upward internal force from an embedded nail head can occur when nails are underdriven, leaving a gap between the attached pieces of wood, followed by a subsequent closing of the gap. Lastly, there is the potential that the panels had been previously fastened and then detached (e.g., a re-use or repositioning of the panels). Any of these cases would constitute haphazard workmanship. Other evidence of haphazard workmanship was present, such as a continued end alignment of adjacent panels which is a commonly known condition to avoid and is specifically addressed in published installation instructions for the product. Additionally, the presence of both rink shank and smooth shank nails suggested differing times of nailing application, and with potentially different means such as manual versus pneumatic. This was an indication of an attempt to tighten the connection with secondary nailing or bolster the connections due to existing damaged nailing. Therefore, J.S. Held concluded that:

Photo 18: View of Living Room area with OSB spalls. Note the aligned butt joint location of several adjacent panels (blue oval).

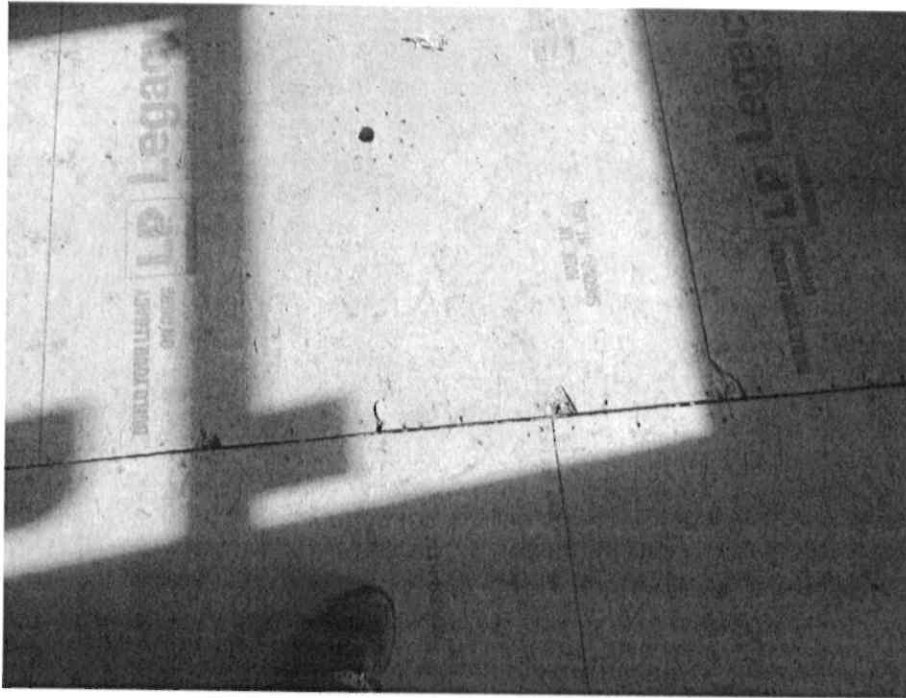
Photo 19: View of the OSB spalls within the Living Room area.

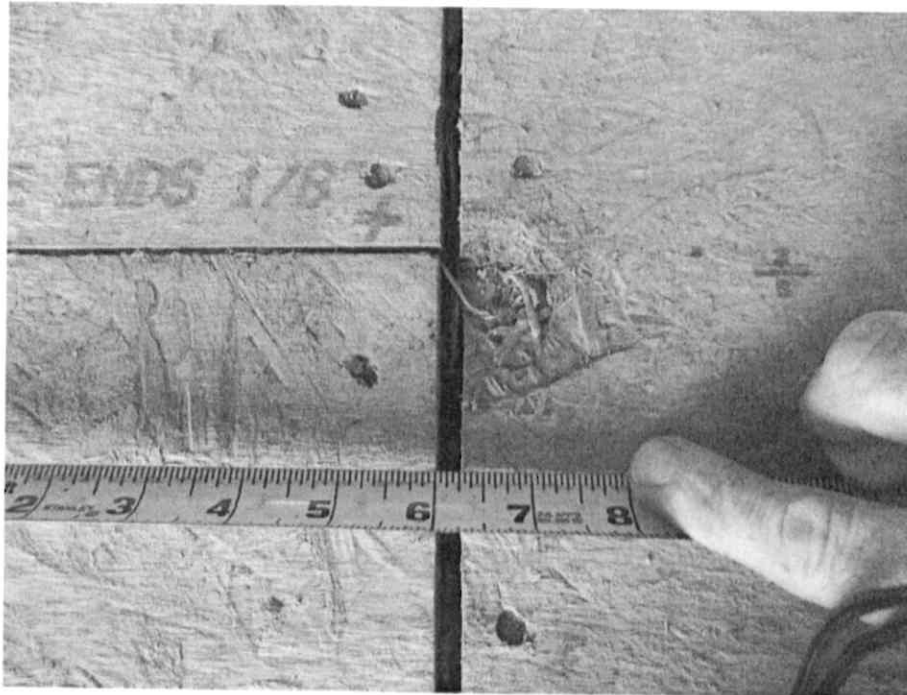
Photo 20: View of a typical spall in the OSB subfloor.

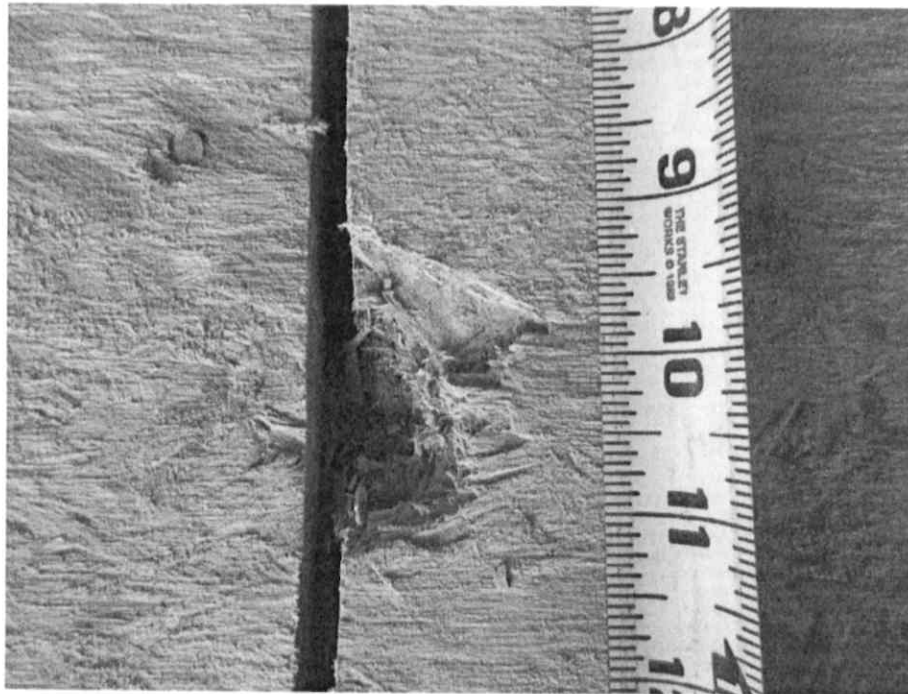
Photo 21: View of a typical spall in the OSB subfloor.

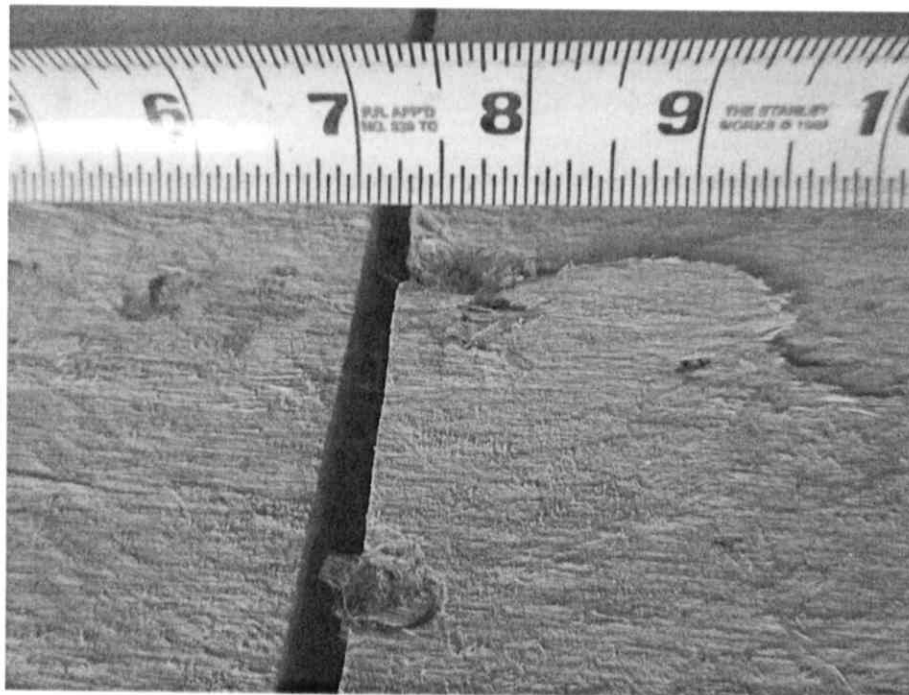
Photo 22: View of an upward delaminated surface of the OSB.

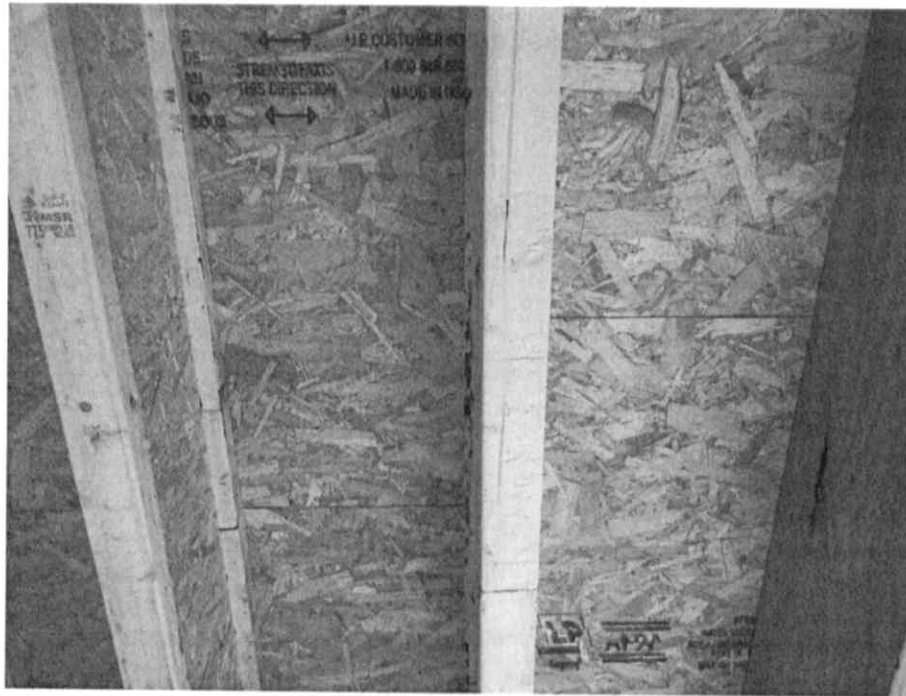
Photo 23: View of underside of panel with OSB spalls.

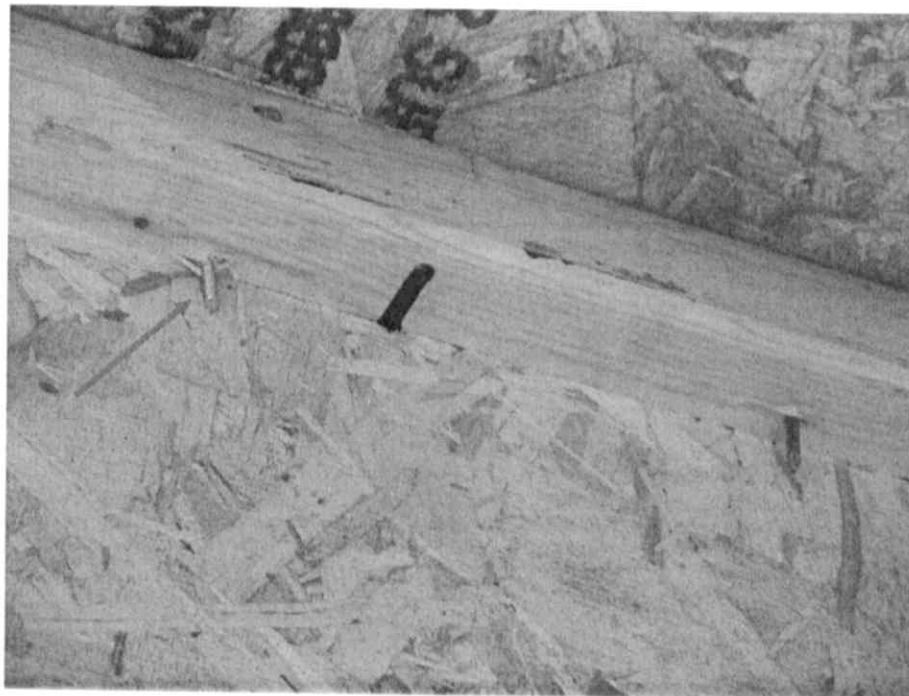
Photo 24: View of underside of spalled OSB panel showing a ring shank nail (red arrow) and a smooth shank nail (blue arrow) fastening the OSB to the top of the floor joist.

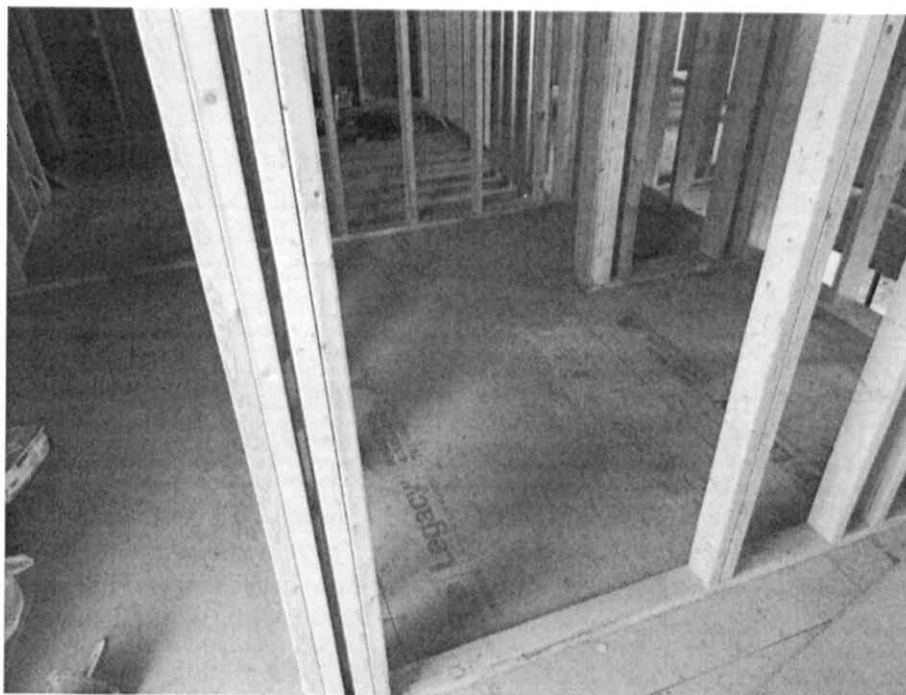
In some locations of the main level interior floor, such as around the Bath 2 area (as labeled on Sheet A5 of the architectural plans), the top surface of the OSB exhibited a dark stain coloration consistent with being wetted by water or other liquid. In some instances, dark discoloration was visible to the bottom edges of interior partition wall baseplates where in contact with the OSB. No physical damage was noted at these locations other than superficial discoloration. Separately, isolated instances of delaminated "bubbles" were visible on the surface of the OSB, where the top lam of the OSB had delaminated and raised upward. These delaminated areas were less than 4 inches in length and 1 inch in width and did not coincide with discoloration stains on the floor surface. (Appendix A, Photos 25-29)

The owner had reported rainwater entering into the house through the rough roof framing, prior to the installation of the shingle roof covering, for approximately three months. Wetting of rough framing is commonplace during rough construction, and isolated wettings do not cause damage to wood framing components when subsequent drying occurs within a reasonable amount of time. This was reinforced in the published literature by the OSB manufacturer which stated, "*Exposure to reasonable precipitation during normal construction delays will not damage the panels.*" As such, the mere presence of water onto the OSB panels, and subsequent discoloration staining thereof, does not constitute damage.

Various areas of the main level exhibited water stains to the top surface of the main subfloor sheathing panels and/or to the bottom edges of sole plates at interior partition walls, which was consistent with exposure to rainwater or other liquids during rough construction. The liquid exposure and stains did not constitute damage and instead are normal and expected conditions of typical residential rough framing prior to dry-in.

Photo 25: View of the Bath 2 area of the main level floor, showing water stains to the surface of the OSB subfloor.

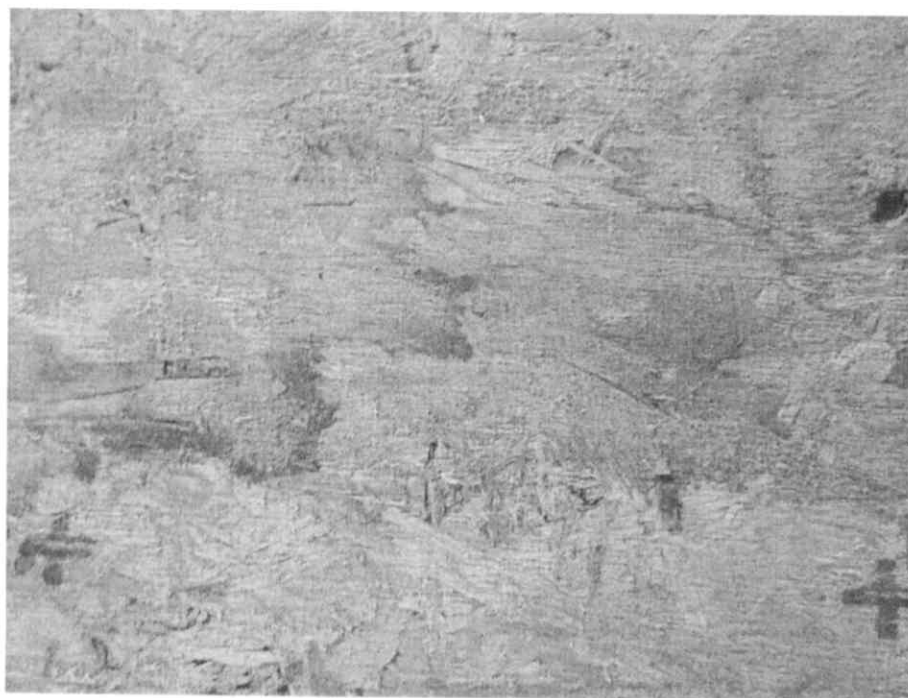
Photo 26: Closer view of water stains to the OSB subfloor.

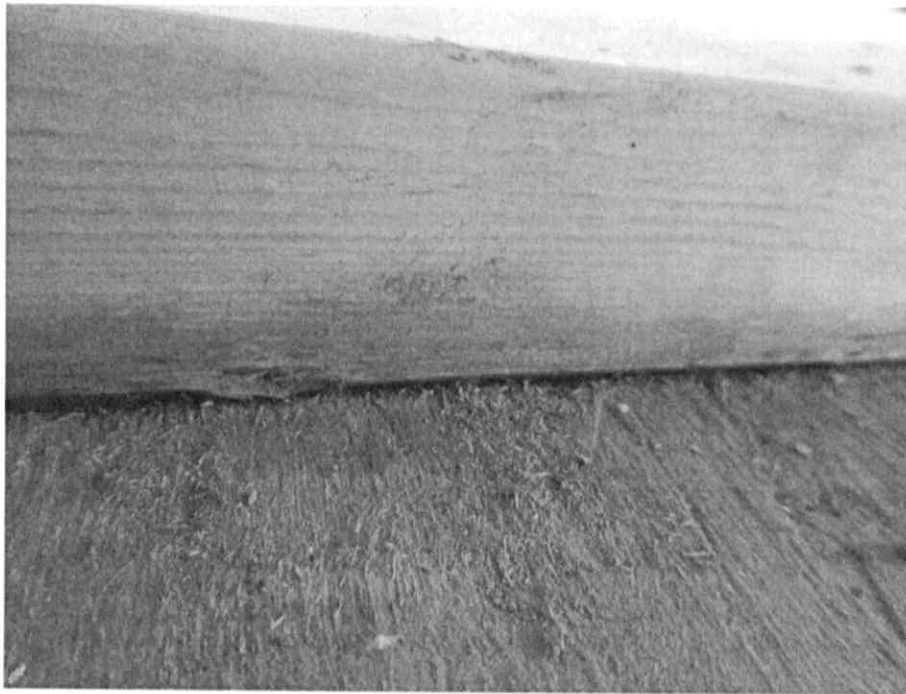
Photo 27: View of water stains at the bottom edge of a wood plate at interior partition wall.

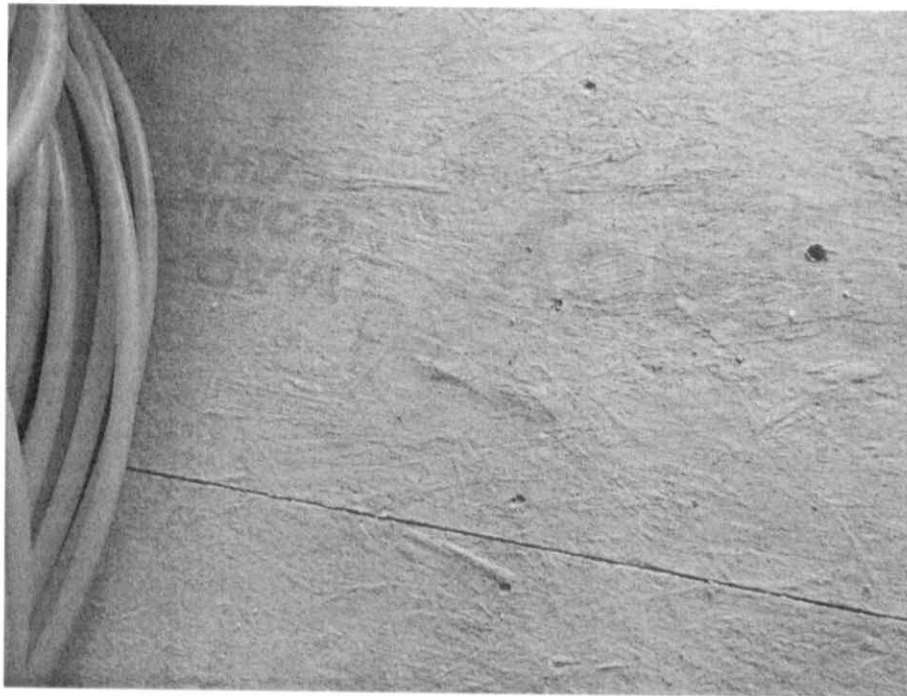
Conversely, OSB can begin to delaminate if held in wetted conditions for prolonged periods of time. The isolated instances of delaminated OSB were without coincident water stains, which indicated a lack of prolonged wetted conditions to those areas. That, coupled with the relatively small and discrete sizes of the delamination made them consistent with anomalies inherent to the OSB product rather than incurred damage.

Photo 28: View of isolated area with delamination of top OSB ply. See also next photo.

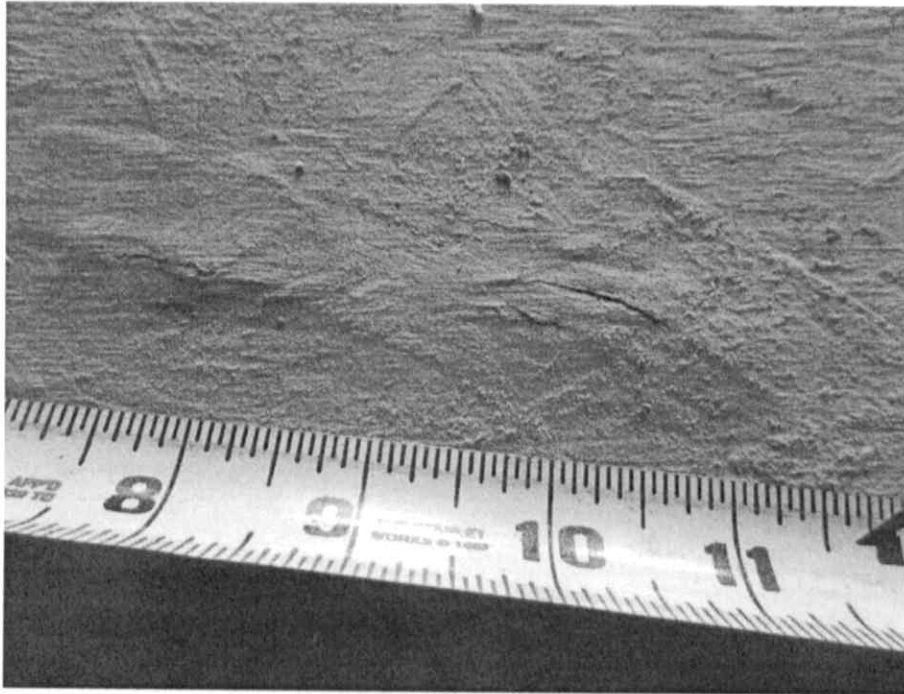
Photo 29: View of isolated area with delamination of top OSB ply.
